FIRE SAFETY FOLLOW UP INSPECTION

Factory Name	Garib & Garib Company Ltd (Unit-2)	Accord ID	9490
Address	Vogra, Gazipur		
Inspection Date	17/04/2014	Report Received Date	17/08/2014
Date of 1st Follow-up	06/03/2015	Date of 2nd Follow-up	29/12/2015
Date of 3rd Follow-up	20/04/2016	Date of 4th Follow-up	29/06/2016
Date of 5th Follow-up	31/10/2016	Date of 6th Follow-up	03/01/2017
Date of 7th Follow-up	04/04/2017	Date of 8th Follow-up	20/07/2017
Date of 9th Follow-up	18/12/2017	Date of 10th Follow-up	08/04/2018
Date of 11th Follow-up	17/09/2018	Date of 12th Follow-up	25/03/2019
Inspected by	Md. Rakibul Alam

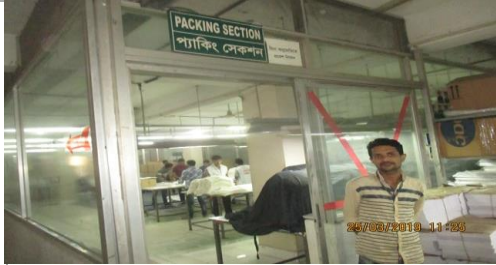
9	Battery storage was located in the south exit stair.	Remove all storage from exit stairs and egress paths.	Immediate	On 31.10.2016: Corrected. On 03.01.2017: Corrected. On 4-4-2017: Corrected. On 20/07/17: Corrected. On 18/12/17: Corrected. On 08/04/2018: Removed. On 17/09/2018: Corrected	'29/12/2015	Corrected	Corrected	 
10	Sliding doors are provided at building exits, exit stairs and exit discharge.	Replace all gates and sliding doors along the means of egress with side-hinged, swinging egress doors. If locks are required for security reasons, utilize special door locking features complying with IFPA 101.	Within 1 month	On 31.10.2016: Corrected. On 03.01.2017: Corrected. On 20/07/17: Corrected. On 18/12/17: Corrected. On 08/04/2018: Modified. On 17/09/2018: Corrected On 25/03/2019: Sliding gates shall be removed from packing section and store rooms.	'01/10/2016	Corrected	Corrected

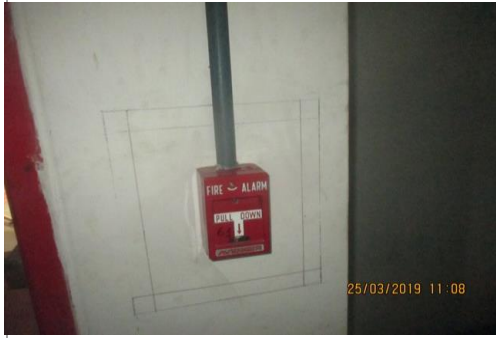
Item No	Accord Inspection Observation	Accord Action Plan (Recommendation)	Accord Timeline (given in report)	Comments from Accord (after Physical Inspection)	Final Approved Timeline (DD/MM/YYYY)	Final Action Plan (Factory)	Progress Status (on the date of Inspection)	Pictorial Evidence
11	The fire alarm system is antiquated, not a listed system, and does not provide alarm and notification features consistent with acceptable standards.	Replace the fire alarm system with a new, listed addressable fire alarm system in accordance with NFPA 72.	Design within 4 months, install within 9 months	<p>On 03.01.2017: In progress. Modification/installation shall be completed as per reviewed drawing.</p> <p>On 4-4-2017: L/C has been opened on February 20.</p> <p>On 20/07/17: Installation is going on.</p> <p>On 18/12/17: Installation is underway.</p> <p>On 08/04/2018: Reportedly Installation has been completed. T&C by ACCORD is required for final acceptance.</p> <p>On 17/09/2018: Installation complete, sent request mail to ACCORD for witness testing. FACP room shall be fire separated.</p> <p>On 25/03/2019: Reportedly request mail has been sent few month ago and factory is waiting for Accord T&C.</p>	'30/04/2016	Factory already offer to accord for testing & commissioning of fire alarm system.	In Progress

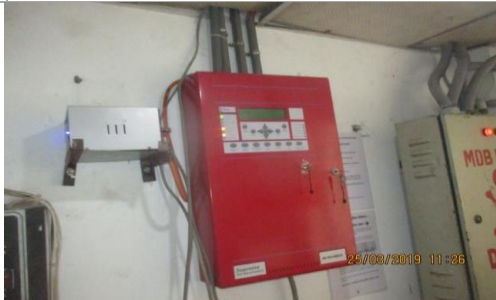
12	Inspection, testing, and maintenance for the fire alarm system was not in accordance with NFPA 72.	Inspect, test and maintain the fire alarm system, and keep written records on-site, in accordance with NFPA 72.	Within 3 months	<p>On 4-4-2017: Same as before.</p> <p>On 20/07/17: In progress.</p> <p>On 18/12/17: In progress. It is an integrated part of addressable fire alarm system.</p> <p>On 08/04/2018: Maintaining.</p> <p>On 17/09/2018: Corrected. Factory shall follow the reference Table-14.3.1 of NFPA-72 (2013).</p> <p>On 25/03/2019: Regular maintenance and trouble shooting is required.</p>	'30/04/2016	Corrected	Corrected

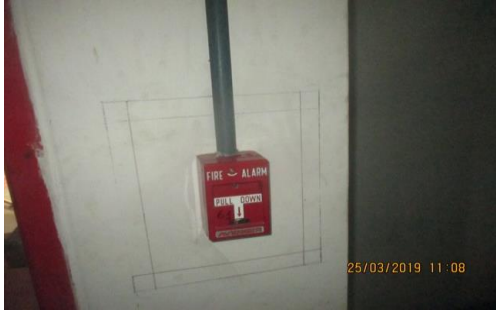
28	The fire alarm system is antiquated, not a listed system, and does not provide alarm and notification features consistent with acceptable standards.	Replace the fire alarm system with a new, listed addressable fire alarm system in accordance with NFPA 72.	Design within 4 months, install within 9 months	On 4-4-2017: L/C has been opened on February 20. On 20/07/17: Installation is going on. On 18/12/17: Installation is underway. On 08/04/2018: Reportedly installation has been completed. T&C by ACCORD is required for final acceptance. On 17/09/2018: Installation complete, sent request mail to ACCORD for witness testing. On 25/03/2019: Reportedly request mail has been sent few month ago and factory is waiting for Accord T&C.	'30/04/2016	Factory already offer to accord for testing & commissioning of fire alarm system.	In Progress

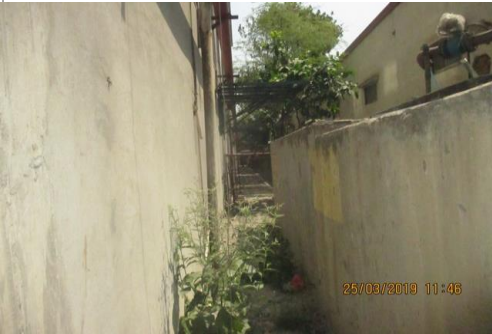
34	New Finding: Exit passageway is not separated by fire rated construction. Location: Exit discharge path of South-west stair.	Separate the exit passageway (windows of finished goods store on of ground floor) by 2-hr fire-resistance rated construction and shall terminate at an exit discharge.	Within 2 months	On 03.01.2017: No action has been taken yet. On 4-4-2017: Same as before. On 20/07/17: It has been found same as before. On 18/12/17: Found same as last FUI. On 08/04/2018: Construction work hasn't been finished yet. On 17/09/2018: Corrected On 25/03/2019: Egress path surface shall smooth and free from any obstructions.	'30/05/2016	Pending Verification	Corrected

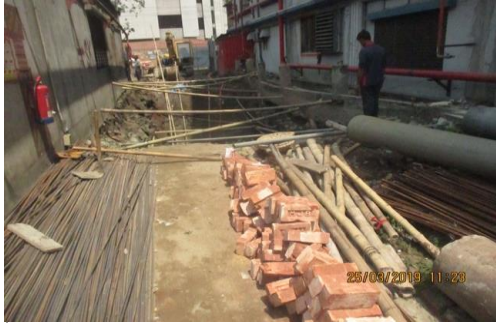
Item No	Accord Inspection Observation	Accord Action Plan (Recommendation)	Accord Timeline (given in report)	Comments from Accord (after Physical Inspection)	Final Approved Timeline (DD/MM/YYYY)	Final Action Plan (Factory)	Progress Status (on the date of Inspection)	Pictorial Evidence
35	New Finding: The existing factory building with an occupiable floor greater than 10 m (33 ft) above the finished grade is not protected with an approved standpipe system.	Provide a standpipe system throughout the building in accordance with NFPA 14.	Design review within 2 months and installation within 4 months	On 4-4-2017: L/C has been opened reportedly on March 23. On 20/07/17: It has been found same as before. On 18/12/17: In progress. Required materials are in housed. Installation has not started yet. On 08/04/2018: Pump installation is pending. Water reservoir construction is ongoing. On 17/09/2018: Piping complete, pump in housed, construction will be started very soon. On 25/03/2019: Construction work is going on.	'31/05/2016	Factory already installed pipe, cabinet box & fire briget point but factory can't completed water reservoir & pump house due to financial crisis.	In Progress

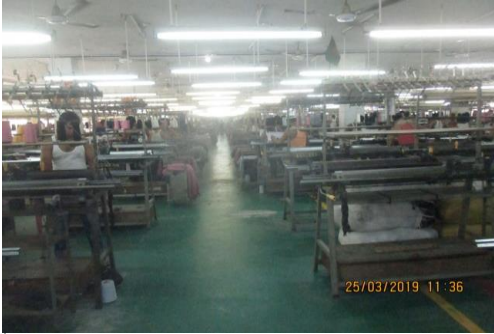
40	New Finding (3rd Follow-up): Width of aisles is less than 0.9m (36-in.) and few areas, aisles have not been provided. Location: Building of Unit-1	Aisles shall be provided with a minimum unobstructed clear-width of 0.9 m (36 in.).	Within 01 Month	On 4-4-2017: Still need modification at several aisles. On 20/07/17: Still need modification at several aisles. On 18/12/17: No progress since last FUI. On 08/04/2018: Corrected. Cleared. On 17/09/2018: Corrected On 25/03/2019: Currently factory is modifying their floor layout (unit-1), egress and aisles shall comply Accord standard for both building/unit.	'20/05/2016	Corrected	Corrected

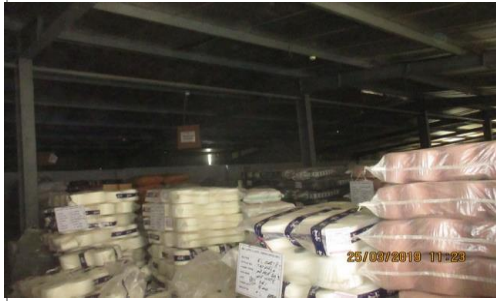
Item No	Accord Inspection Observation	Accord Action Plan (Recommendation)	Accord Timeline (given in report)	Comments from Accord (after Physical Inspection)	Final Approved Timeline (DD/MM/YYYY)	Final Action Plan (Factory)	Progress Status (on the date of Inspection)	Pictorial Evidence
49	New Finding (7th follow-up): Sliding is provided at winding section at the north-east exit passageway.	Replace all gates and sliding doors along the means of egress with side-hinged, swinging egress doors. If locks are required for security reasons, utilize special door locking features complying with NFPA 101.	Within 15 days	NEW FINDING (7th) On 20/07/17: Corrected. On 18/12/17: Corrected. On 08/04/2018: Replaced. On 17/09/2018: Corrected On 25/03/2019: Sliding gates shall be removed from packing section and store rooms.	'20/04/2017	Corrected	Corrected

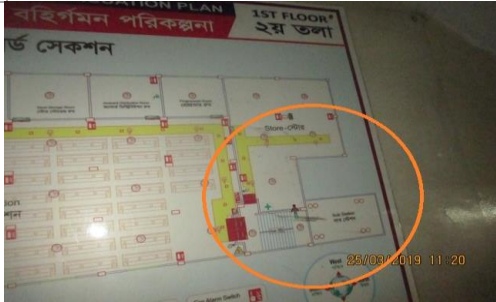
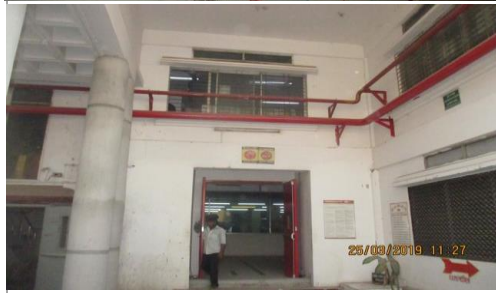
50	New Finding: N-E exit stair is not properly protected from building interior.	Exterior exit stairs shall be separated from the building with a 2-hr fire rated construction. The rating of the exterior wall shall extend 3.05 m (10 ft) beyond the ends of the stair structure. At exit discharge level, seal/separate all unprotected openings with 2-hr fire rated construction/material.	Within 2 months		25-05-2019
