### Structural Safety Inspection

Factory Name	Garib & Garib Company Ltd (Unit-2)	Accord ID	9490
Factory Address	Vogra, Gazipur		
Inspection Date	30/03/2014		
Date of Review Inspection	13-Dec-18		
Inspected by	Sourav Dutta

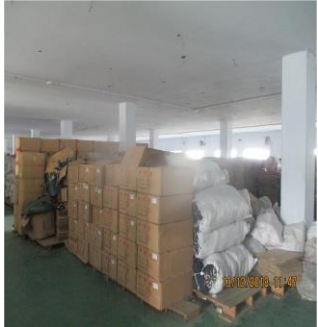
Item No	Accord Observation	Accord Recommendation	Accord Timeline	Final Action Plan	Final Timeline( DD/MM/YYYY)	Comments after Physical Inspection	Progress Status	Pictorial Evidence
1	Verify concrete strengths in all columns in Building 1	Maintain current use of the floors and don't change use or increase occupation, either of which could increase loading. Loading in areas of high storage of clothing and gravel on roof to be reduced so that maximum floor loading of 2kN/m2 is maintained.	(Immediate -Now)	Corrected	'03/06/2015	<p><b>On 06 .03.2015:</b> DEA has approved. On verification period we found that they maintain load plan as per approved DEA documents.</p> <p><b>On 04.04.2017:</b> During inspection loading was found less than 42 psf. This issue was corrected in previous inspection and remains corrected.</p> <p><b>On 12.07.2017:</b> Corrected in the previous follow up report. Loading was found below 42 psf.</p> <p><b>On 19-Dec-2017:</b> Loading was observed below 42psf. This issue was found corrected from previous follow up inspection.</p> <p><b>On 08-May-2018:</b> This issue was corrected from previous inspection. Load plan has been produced and accepted from ACCORD. During inspection safe load plan was found posted on floor. Load was found as per load plan.</p> <p><b>On 22th Nov 2018:</b> Corrected from previous inspection. During inspection load was found below the allowable limit (42psf).</p> <p><b>On 13th December 2018:</b> Corrected previously. During inspection, load was found below the allowable limit (42psf).</p>	Corrected

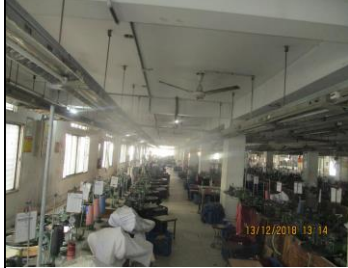
7	Verify concrete strengths in all columns in Building 1	Continue to implement load plan	(within 6-months)	Corrected	*03/06/2015	<p><b>On 06 .03.2015:</b> DEA has approved. On verification period we found that they maintain load plan as per approved DEA documents.</p> <p><b>04.04.2017:</b> Loads were found less than 30 psf which is less then the load plan that accepted along with DEA.</p> <p><b>On 12.07.2017:</b> Before retrofitting Load plan was posted on the wall and load found under acceptable limit. This issue will be finalized after retrofitting works completion.</p> <p><b>On 19-Dec-2017:</b> As part of DEA, factory designated consultant prepared load plans for all buildings. Load was found more than the safe load limit. However, safe load plan has not been posted yet. Factory is required to post the safe load plan on every floor and maintain the loading limit as per safe load plan. After completing remedial works, factory must follow the final load plan and post in every floor.</p> <p><b>On 08-May-2018:</b> This issue was corrected from previous inspection. Load plan was produced as part of DEA, which was accepted from ACCORD. During inspection, safe load plan was found posted on floor due to retrofitting ongoing. After completing remedial works, factory must follow the final load plan and need to post in every floor.</p> <p><b>On 22th Nov 2018:</b> Corrected from previous inspection. During inspection load was found below the allowable limit (42psf).</p> <p><b>On 13th December 2018:</b> Corrected previously. During inspection load was found below the allowable limit (42psf).</p>	Corrected

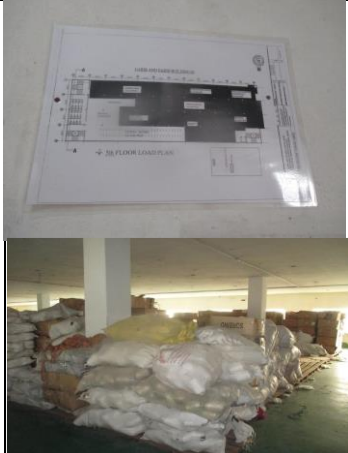
15	Verify concrete strengths in columns noted in Building 3	Verify insitu concrete stresses either by 100mm diameter cores or existing cylinder strength data for cores from 4 columns.	(Immediate -Now)	Corrected	'03/06/2015	<p><b>On 06 .03.2015:</b> The factory collected core and tested from DUET.</p> <p><b>On 04.04.2017:</b> The factory collected core and tested from DUET as a part of DEA. During inspection core location was verified and original core test report was available.</p> <p><b>On 12.07.2017:</b> Corrected in the previous follow up report.</p> <p><b>On 19-Dec-2017:</b> Issue remains corrected from previous follow up inspection.</p> <p><b>On 08-May-2018:</b> This issue was corrected from previous inspection.</p> <p><b>On 22th Nov 2018:</b> Corrected from previous inspection.</p> <p><b>On 13th December 2018:</b> Corrected previously.</p>	Corrected	
16	Verify concrete strengths in columns noted in Building 3	Produce and actively manage a loading plan for all floor plates within the factory giving consideration to floor capacity and column capacity.	(within 6-weeks)	Pending Verification	'31/03/2016	<p><b>On 06 .03.2015:</b> Column orientation do not match with actual condition and .In this building flat slab, no column drop panel, no outer beam and no RCC shear wall which may bring serious changes in the DEA.</p> <p><b>On 04.04.2017:</b> Loads are found less than accepted load plan according to approved DEA.</p> <p><b>On 12.07.2017:</b> Before retrofitting Load plan was posted on the wall and load found more then acceptable limit. This issue will be finalized after retrofitting works completion.</p> <p><b>On 19-Dec-2017:</b> As part of DEA, factory designated consultant prepared load plans for all buildings. Load was found more than the safe load limit. However, safe load plan has not been posted yet. Factory is required to post the safe load plan on every floor and maintain the loading limit as per safe load plan. After completing remedial works, factory must follow the final load plan and post in every floor.</p> <p><b>On 08-May-2018:</b> Load plan was produced as part of DEA, which was accepted from ACCORD. During inspection, safe load plan was found posted on floor due to retrofitting ongoing. After completing remedial works, factory must follow the final load plan and need to post in every floor.</p> <p><b>On 22th Nov 2018:</b> Factory has completed all retrofitting works in Building-3. During inspection load plan was found posted at every floor and load was found below the allowable limit (42psf) at every floor.</p> <p><b>On 13th December 2018:</b> Corrected previously. Loading was observed within 42 psf.</p>	Corrected

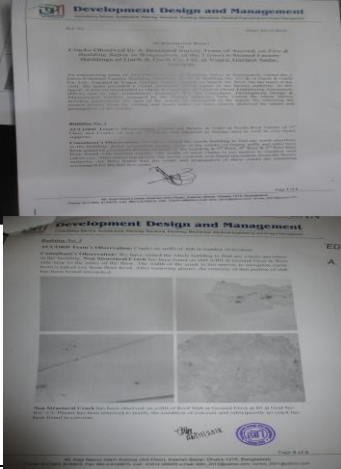
Item No	Accord Observation	Accord Recommendation	Accord Timeline	Final Action Plan	Final Timeline( DD/MM/ YYYY)	Comments after Physical Inspection	Progress Status	Pictorial Evidence
20	Cracking on the soffit of flat slabs.	Building engineer to check the structures and make proposals for the remediation measures, if required	(within 6-weeks)	Pending Verification	*31/08/2016	<p><b>On 06 .03.2015:</b> Covered in DEA report</p> <p><b>On 04.04.2017:</b> Covered in DEA report. Some discrepancies were found during inspection. Factory will have to submit corrected DEA within 30 April, 2017.</p> <p><b>On 12.07.2017:</b> After verification, discrepancy was observed on building-3 and factory got re-acceptance from Accord on 15 Jun, 2017. Required remediation was on going.</p> <p><b>On 19-Dec-2017:</b> DEA was re-accepted on 15th June 2017. During inspection, remedial works were found on going.</p> <p><b>On 08-May-2018:</b> Factory has take some remedial action regarding cracks repairing, which was not complete yet.</p> <p><b>On 22th Nov 2018:</b> Factory has completed all retrofitting works in Building-3 but during inspection some discrepancies have been found between retrofitting drawing and retrofitted condition. Dimension of stair beam for ground floor didn't match with retrofitting drawing and 12 rebar were found instead of 16 rebar for Column C-7 at 1st floor. After checking the change in after retrofitting FEM model it has been found satisfactory. Retrofitting completion certificate has also been provided by the factory consultant. Also, as per crack investigation report, all cracks are non structural and no remediation works is required for those cracks.</p> <p><b>On 13th December 2018:</b> Corrected previously.</p>	Corrected

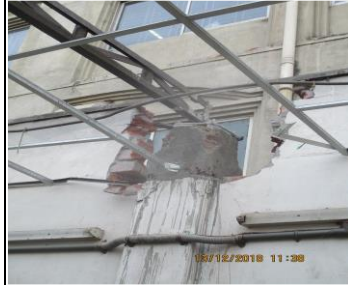
Item No	Accord Observation	Accord Recommendation	Accord Timeline	Final Action Plan	Final Timeline( DD/MM/ YYYY)	Comments after Physical Inspection	Progress Status	Pictorial Evidence
22	Concrete column removed at Boiler House.	Building engineer to check the structures and make proposals for remedial measures, if required	(within 6-months)	Factory already submitted EA by 26th April and completed recification works in Generator room.	'31/08/2016	<p><b>On 06_03.2015:</b> Covered in DEA report</p> <p><b>On 04.04.2017:</b> Concrete column found discontinuous. This issue has to be covered in DEA.</p> <p><b>On 12.07.2017:</b> Concrete column found discontinuous. This issue is covered in DEA, which is under review.</p> <p><b>On 19-Dec-2017:</b> This issue is required to be covered in DEA. DEA report of ancillary building has not been submitted yet. Factory management is required to submit the DEA to ACCORD office. After acceptance, remedial works shall be carried out if required.</p> <p><b>On 08-May-2018:</b> Factory has submitted the design check report and remediation plan to ACCORD, which is under review.</p> <p><b>On 22th Nov 2018:</b> This issue is required to be covered in EA. Factory has submitted EA for ancillary structures on 4th Nov 2018 and review comments sent from Accord on 19th Nov 2018. Factory is required to submit revised EA.</p> <p><b>On 13th December 2018:</b> Documents for Ancillary sheds were accepted on 4th December 2018. Retrofitting is required. During inspection, retrofitting works were ongoing.</p>	In Progress
